PHASE I REPORT
NATIONAL DAM INSPECTION PROGRAM.

NAME OF DAM: Ebensburg Storage Dam (NDI ID Number PA-00442,
STATE LOCATED: Pennsylvania DER ID Number 11-61), Ohio
COUNTY LOCATED: Cambria River Basin (Maries Woods Run)
STREAM: Howell's Run Howells Run, Cambria County,
SIZE CLASSIFICATION: Small Pennsylvania. Phase I Inspection
HAZARD CLASSIFICATION: High Report,
OWNER: Borough of Ebensburg
DATE OF INSPECTION: November 14 and December 12, 1979

EBENSBURG STORAGE DAM
NDI I.D. PA-422
NOVEMBER 14, 1979

PHASE I REPORT
NATIONAL DAM INSPECTION PROGRAM
EBENSBURG STORAGE DAM
NDI I.D. PA 442
DER I.D. 11-61

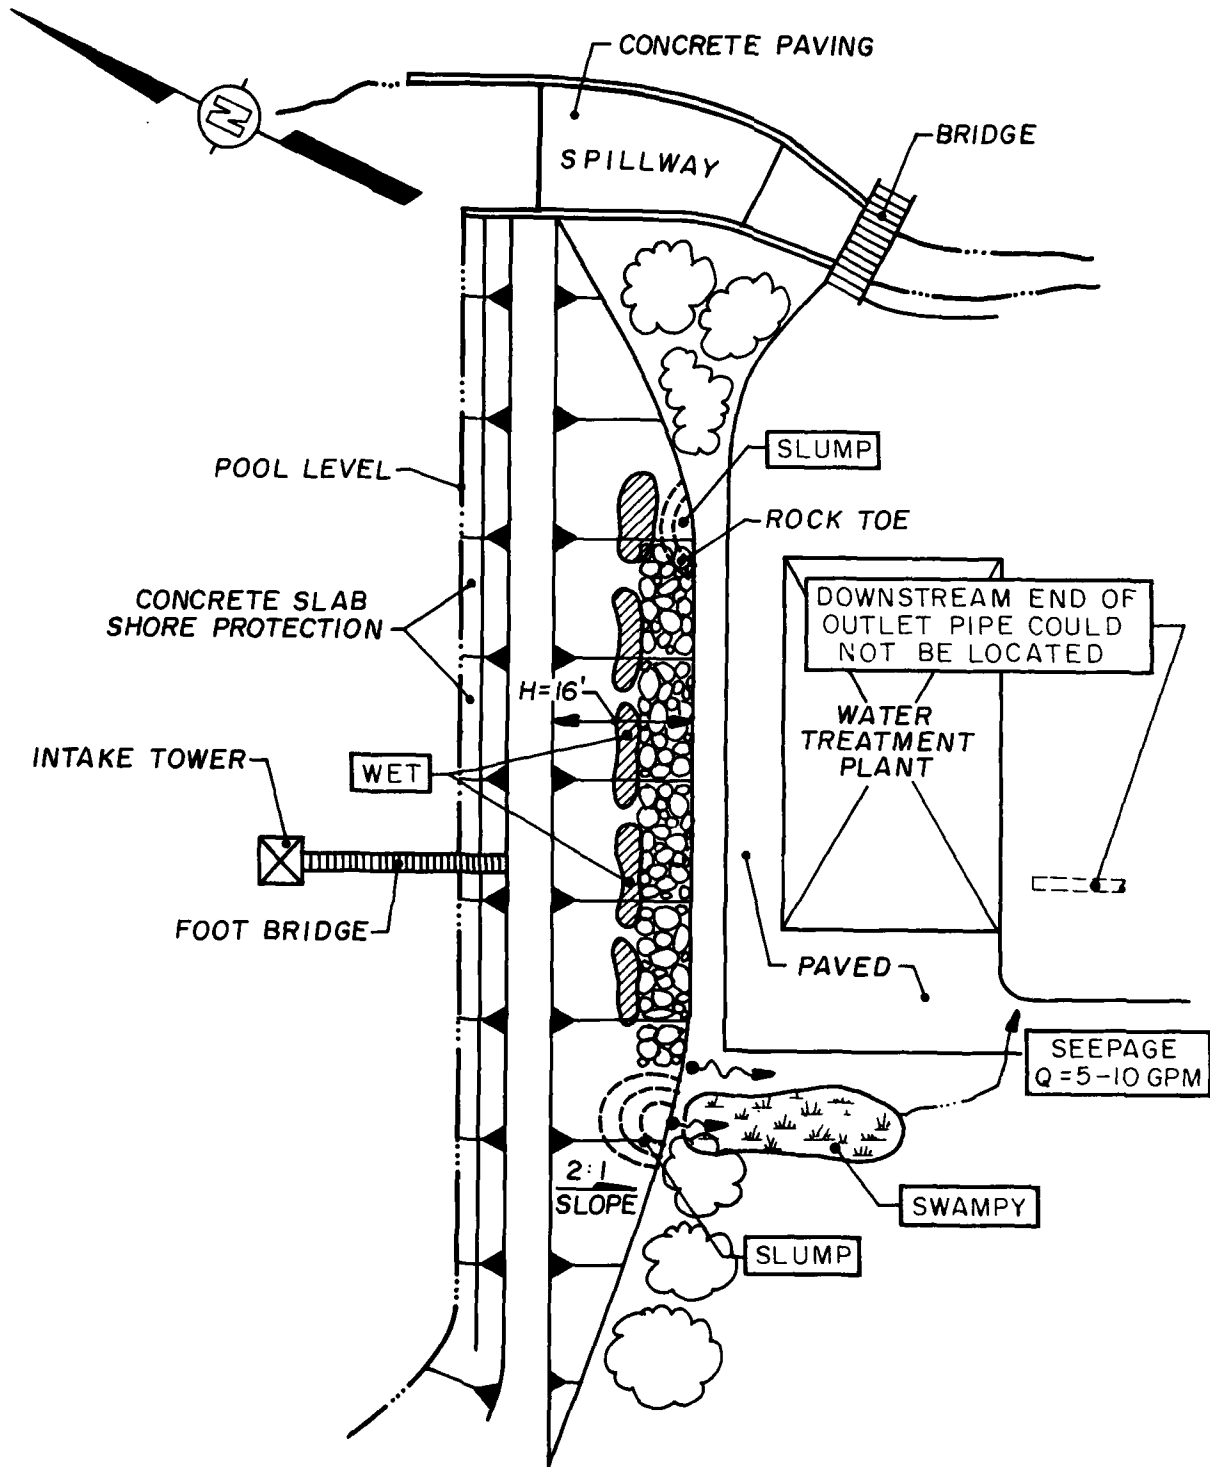
The two most significant conditions noted at the dam site were the presence of wet areas in a the middle half of the downstream slope starting at a level about 8 feet from the crest level and extending to the toe of the embankment. Two slumps associated with this seepage through the embankment are located on each side of the rock-fill along the toe of the dam. The slump located on the right side of the rock toe appears to cover an area approximately 30 feet long and has settled by about three to four feet relative to the original downstream slope. A swampy area is located below the toe of the dam in line with this slump. The discharge from the seepage area is estimated to be on the order of 5 to 10 gallons per minute. No measurable seepage appears to be associated with the wet areas on the remaining portion of the downstream slope.

VISUAL EXAMINATION OF	OBSERVATIONS	REMARKS OR RECOMMENDATIONS
JUNCTION OF EMBANKMENT AND ABUTMENT, SPILLWAY AND DAM	No signs of distress.	
ANY NOTICEABLE SEEPAGE	See Plate 6 for location of wet areas and seepage points.	
STAFF GAGE AND RECORDER	None	
DRAINS	None

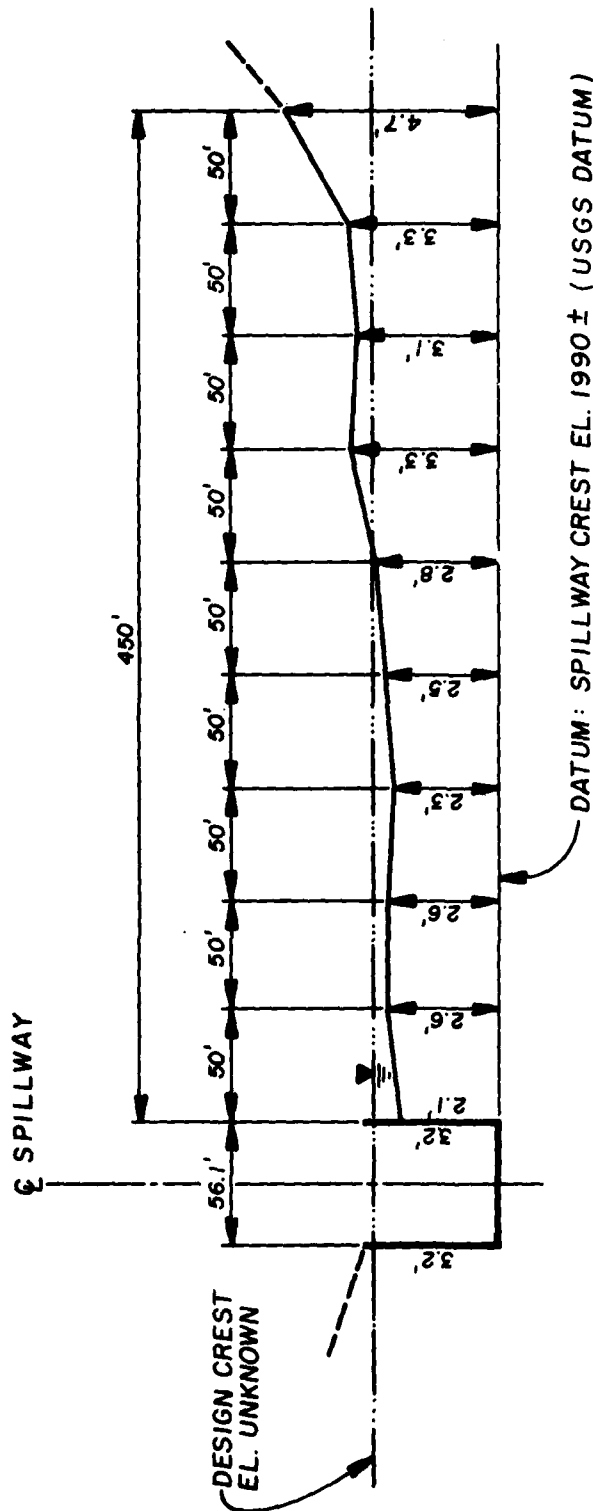
DAM CREST PROFILE (LOOKING DOWNSTREAM)

The crest of the dam was surveyed relative to the spillway crest level. The freeboard was found to range from 2.5 feet adjacent to the spillway wall to about 4.7 feet near the right abutment. A 200-foot section of the crest measured from the spillway side was found to be below the top of the spillway wall elevation, which was presumed to be the design elevation for the embankment crest. The dam crest profile is illustrated in Plate 7.

2. In conjunction with the detailed evaluation of the dam, the crest of the dam should be surveyed and the low spot filled to the design elevation.
3. The operational condition of the sluice gate should be evaluated and necessary maintenance performed.
